DEPARTMENT OF TRANSPORTATION

Contract #: 04-0120F4Cty: SF/ALA Rte: 80 PM: 13.2/13.9File #: 99.28**WELDING INSPECTION REPORT****Resident Engineer:**Siegenthaler, Peter**Address:** 333 Burma Road**City:** Oakland, CA 94607**Report No:** WIR-024829**Date Inspected:** 01-Jul-2011**Project Name:** SAS Superstructure**OSM Arrival Time:** 700**Prime Contractor:** American Bridge/Fluor Enterprises, a JV**OSM Departure Time:** 1900**Contractor:** Zhenhua Port Machinery Company, Ltd (ZPMC) Chanxing Island**Location:** Shanghai, China

Bridge No: 34-0006**Component:** OBG Segment**Summary of Items Observed:**

OBG Segment 13CW

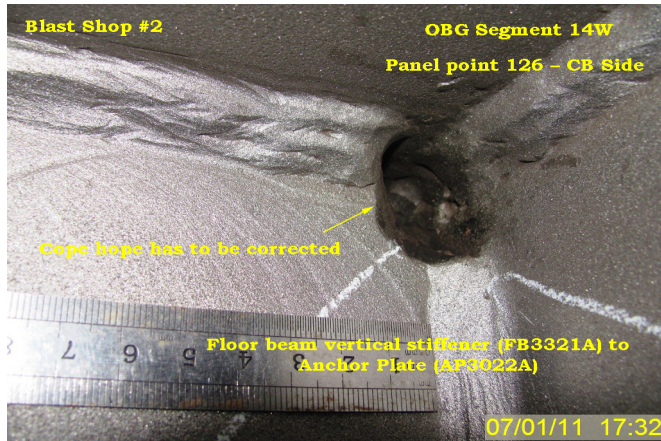
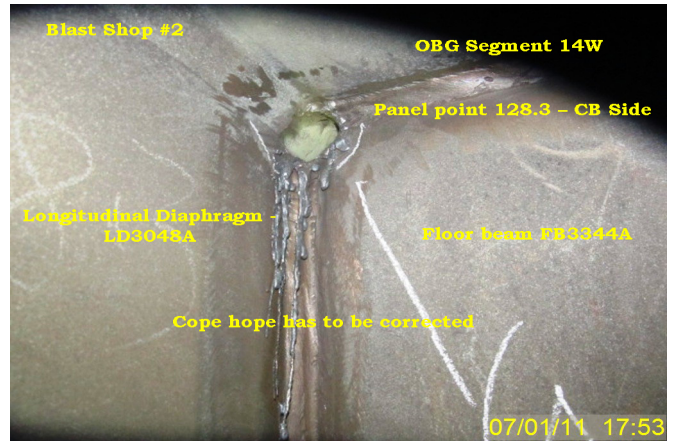
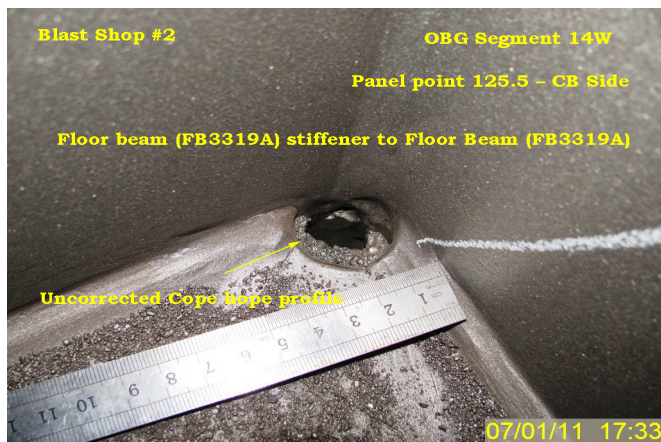
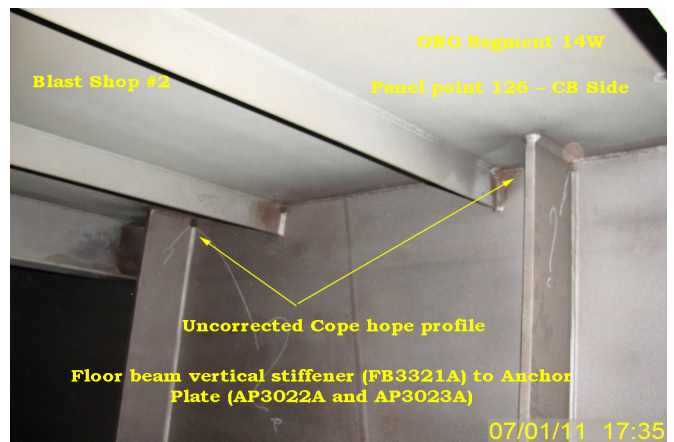
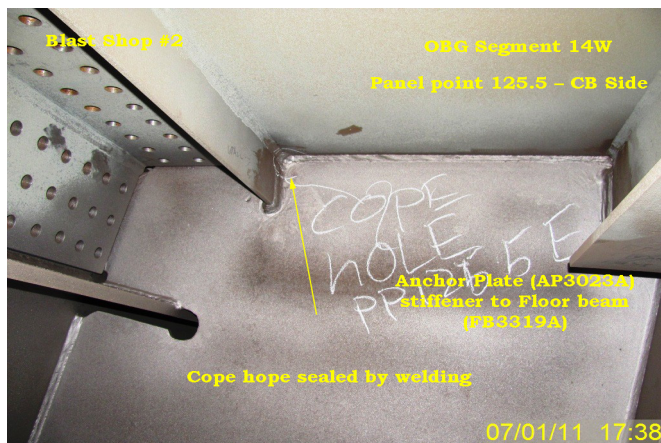
Visual inspection after the blasting: During random Quality Assurance Visual review of welds located on OBG Segment 14W, this Quality Assurance Inspector (QA) observed following details:

- In between PP128 and PP128.3 cross beam side, incomplete welding on side plate (SP3140E) to edge plate (EP3030E).
- At PP128.3 (W) cross beam side, excess weld metal on deck panel longitudinal diaphragm (DP3175A) to Longitudinal diaphragm (LD3048A).

- At PP128.3 (W) cross beam side, cope hole profile need to be corrected on deck panel longitudinal diaphragm (DP3048A) to Floor Beam (FB3344A).
- At PP126 (E) cross beam side, approximately 4mm deep grinding on floor beam (FB3321A) to RS stiffener (X4903G – section D).

- At PP127 (E) cross beam side, incomplete welding on edge beam (EB3057A) to Floor Beam (FB3329A)
- At PP125 (W) cross beam side, scattered porosity observed on Edge Plate (EP3030A) to RS Stiffener (RS3497C) weld. Areas were taped prior to blast and paint.

- At PP125 (W) cross beam side, two locations base metal gouge was visibly observed on the longitudinal diaphragm (LD3048).
- At PP 126, vertical I-rib on FB 3321A to top anchorage plate AP 3022A weld joints SEG3020R-262/263; cope hole need to be corrected.

- At PP 126, weld joint SEG3020R-020 observed as incomplete; need to do welding.
- At PP 125.5, the base metal observed as gouged out near toe of the weld joint SEG3020T-095

- At PP 125.5, cluster porosity observed on weld joint SEG3020T-106.
- At PP 125.5, cope hole observed as sealed by welding on weld joint SEG3020T-329.
- At PP 125.5, cope hole need to be corrected at weld joints FB3319-001-019/020.

- At PP 125.5, the weld joint SEG3020T-295 observed as incomplete at cope hole area of weld joint SEG3020T-334/335.
- At PP 125.5, incomplete welding observed at weld joint SEG3020Z-004.

- Near PP 128.7, base metal observed as gouged out on LD3048A.
- At PP 128.7, base metal observed as gouged out at two locations at cope hole sections of add on weld joints on

I-rib X4853E on FB 3348A.

- At PP 128.3 near W4 location, weld joint SEG3020E-015 observed as incomplete.
- For further information, please see the attached picture
